TURTLE MOUNTAIN FIELD LABORATORY (TMFL): PART 1 –OVERVIEW AND ACTIVITIES

Corey R. Froese¹, & Francisco Moreno²

Abstract: Studies on the South Peak of Turtle Mountain, site of 1903 Frank Slide, conducted over the past century have identified a rock volume of approximately 5 million m³ as the possible source of a future rock avalanche. Since 2003, significant effort has gone into installing and monitoring instrumentation on the South Peak and undertaking various supporting studies. The combination of the instrumentation and recently undertaken remote sensing studies have lead to new insights as to the extent and rate of movements on the mountain. Specifically both spaceborne InSAR and airborne LiDAR have been utilized to understand the movement patterns and identify surface morphology that may lead to re-interpretations of the extent of instability on the mountain. The InSAR data has provided a plot of deformation rates for a large portion of the mountain where no other monitoring equipment exists. The bare earth model from the LiDAR data has allowed for observation large scale surface features that had not previously been appreciated and have lead to an expanded area of concern fo

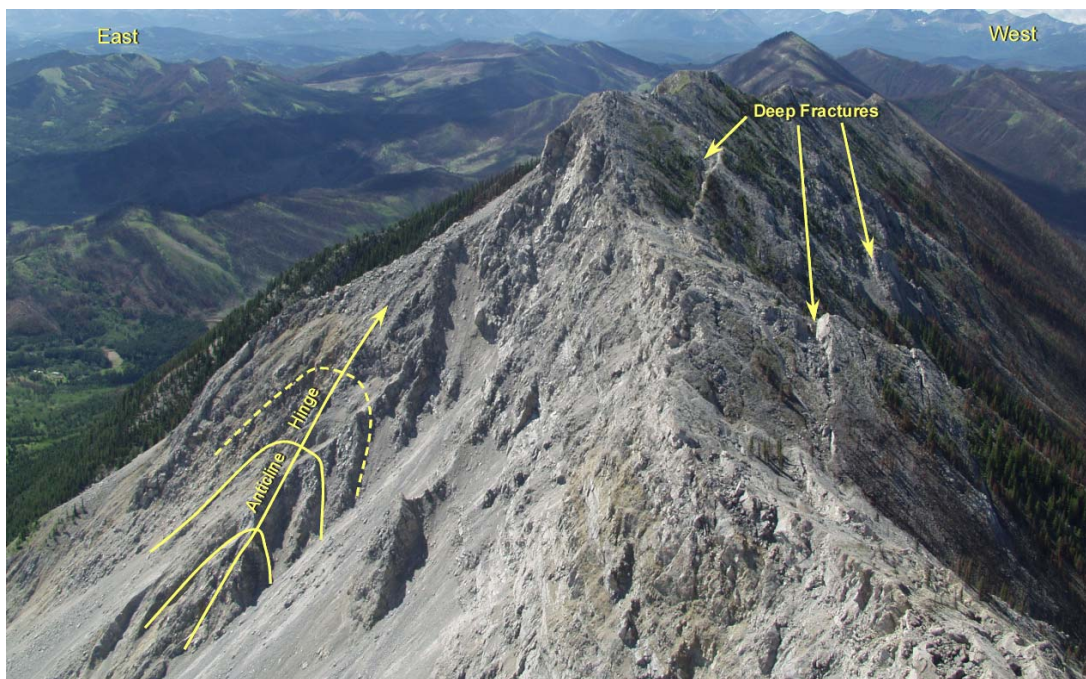
Figure 2. View towards the South Peak showing series of large fractures to the west and the orientation of the anticline hinge downslope, to the east.

Since the identification and mapping of the potential South Peak failure by Allan (1933), efforts have been focused on the mapping and monitoring of a series of deep cracks encompassing the South Peak of Turtle Mountain. The cracks are located upslope and to the west of the hinge of an anticlinal fold (Figure 2). Accounts of surveys before and after the 1903 Frank Slide indicate that the series of cracks opened up in response to the catastrophic slide, and that a mass immediately to the south likely continues to move and may eventually fail catastrophically. Until recently, the postulated mechanism has been assumed to be a through going rupture surface originating from above a thrust fault, located at the toe of the mountain and progressing upslope, through the hinge of the anticline and intersected by the prominent fracture network on the west side of anticline hinge (Figure 2).
