Frank Slide a Century Later: The Turtle Mountain Monitoring Project

ABSTRACT: Turtle Mountain in southwest Alberta, Canada - the site of the 1903 Frank Slide - has been the focus of many studies over the past century. Geotechnical investigations have concluded that there is potential for a subsequent rock avalanche from the South Peak of Turtle Mountain. To reduce the risk associated with a second rock avalanche, the Government of Alberta initiated a two-year multi-disciplinary monitoring project in 2003. The Turtle Mountain Monitoring Project involves implementation of a predictive monitoring system comprising a variety of geotechnical, geophysical, hydrological and other instruments operating in near real-time. The system incorporates an integrated data management strategy linked to emergency response protocol. Site-specific alarm and warning criteria being developed on the basis of monitoring data from Turtle Mountain are the subject of a companion paper. The project represents a state-of-the-art application of geotechnical monitoring technology in an area of significant historical interest from a landslide perspective. Long-term monitoring is planned following completion of th

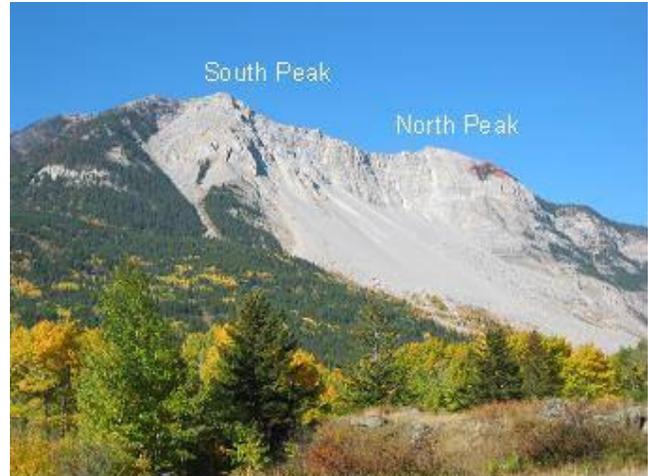
Figure 1. East face of Turtle Mountain showing the 1903 Frank Slide and the prominent North and South Peaks.

The 1903 Slide left two prominent peaks on Turtle Mountain (Fig. 1). South Peak comprises Paleozoic limestone, and rises about 1000 m above the valley floor to an elevation of 2200 m. Studies of South Peak conducted since the 1903 Slide have identified a rock volume of about 5 million cubic metres that could be the source of a future rock avalanche from Turtle Mountain.

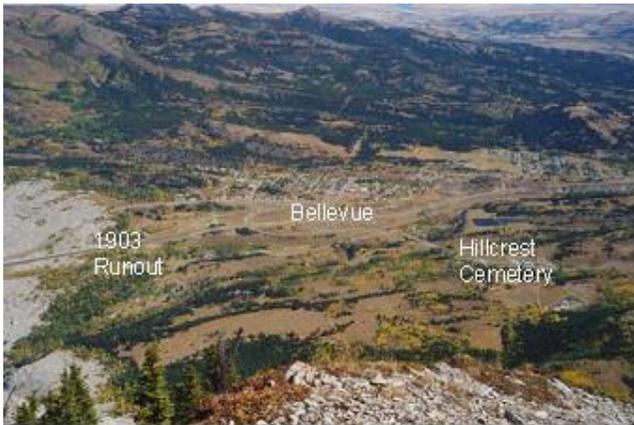
Figure 2. View looking east from South Peak of the potential runout area associated with a rock avalanche from South Peak.

The area of attendant risk (Fig. 2) is bounded by the 1903 Slide runout area, Bellevue to the east, and the Hillcrest cemetery to the south. This area currently contains residences, transportation corridors, recreational facilities, commercial buildings, historic sites, agricultural activities, and utilities. There are currently no land use restrictions outside the 1903 Slide runout area to prevent further development in this area (BGC 2000).

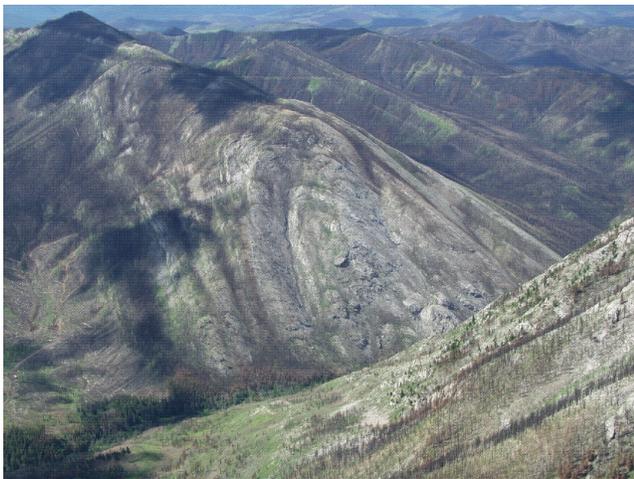
Figure 3. Turtle Mountain Anticline exposed in Hillcrest Mountain looking south across Drum Creek

The geological structure of the mountain, dominated by the Turtle Mountain anticline (Fig. 3) and several thrust faults, is considered the prime contributing factor (Cruden & Krahn 1973). However, mining-related deformation at the toe of the slide, in combination with water and ice accumulation in cracks, is considered a key trigger of the 1903 Slide. The relative importance of these contributing factors continues to be a source of debate amongst experts, and is one of the aspects being studied as part of the Turtle Mountain Monitoring Project.

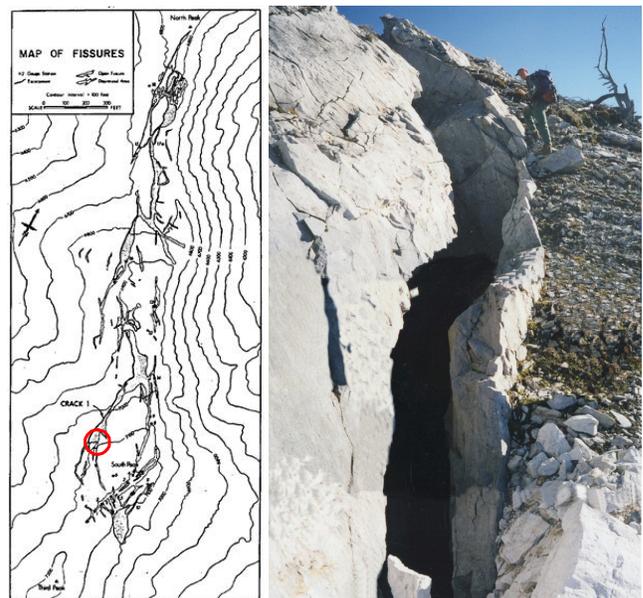
Figure 4: Junction of Crack 1 and a major splay on the west side of South Peak (right), and its approximate location shown by the circle on a reduced copy of Allan's fissure map (left)

The 1903 Slide created a network of deep subvertical tension cracks (fissures) at the crest of Turtle Mountain around South Peak (Fig. 4), extending to within a few metres of North Peak. Monitoring of these fissures commenced shortly after the 1903 Slide as a means of identifying the onset of a subsequent rock avalanche.

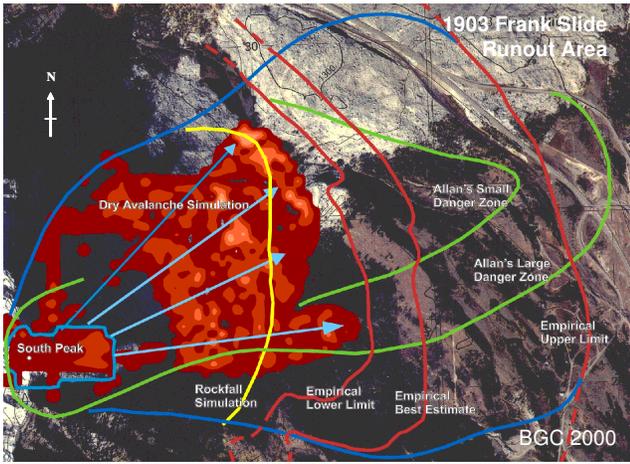
Figure 5: Summary of results from rockfall and rock avalanche analyses performed by BGC Engineering (2000) and earlier estimates by Allan (1931). The empirical upper limit represents the probable maximum hazard zone.

The 2000 study produced an updated estimate of the potential runout area associated with a rock avalanche from South Peak, and possible means of reducing the attendant risk. As shown in Figure 5, Allan's estimates of "danger zones" are generally consistent in distal extent with these recent estimates, but not in shape or lateral extent (Read et al. 2000).

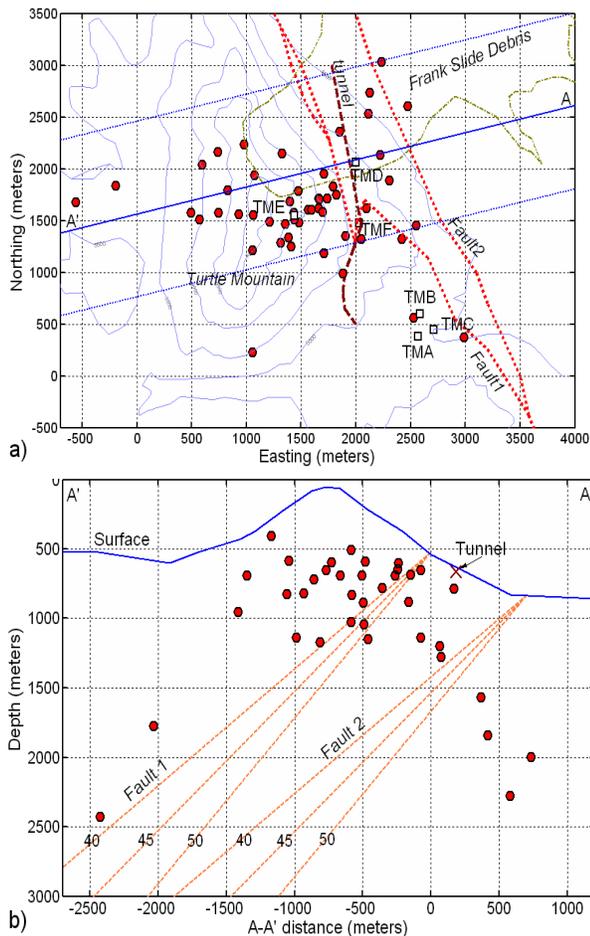
Figure 6: Microseismic results in (a) plan and (b) cross section through Turtle Mountain showing hypocentres of well-resolved events (Chen et al. 2005).

Recent work by Chen et al. (2005) reinterpreted these results, and shows correlation between event location swarms and some geological structures within Turtle Mountain (Fig. 6).

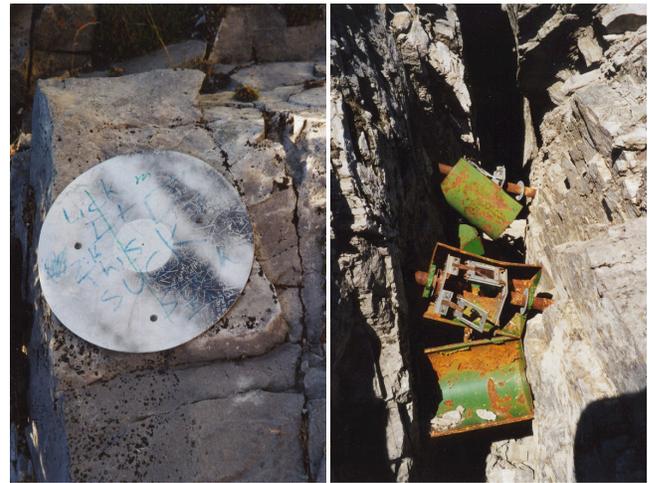
Figure 7: Defaced photogrammetry target (left) and vandalized Moiré crack gauges (right) observed in 1999.

Subsequent monitoring of Turtle Mountain included displacement measurements using high-precision photogrammetry (Fraser & Gruendig 1985; Chapman 1986), electronic distance measurement (EDM) surveys (Anderson & Stoliker 1983), and strain gauges (Peterson & Cruden 1986). Meteorological observations were also recorded at a solar-powered weather station on the mountain. Regular monitoring of Turtle Mountain was discontinued by the early to mid-1990's. Historical instruments and monitoring stations were located and inspected in 1999 as part of a field investigation (BGC 2000). It was found that many of the instruments had been vandalized or destroyed (Fig. 7).

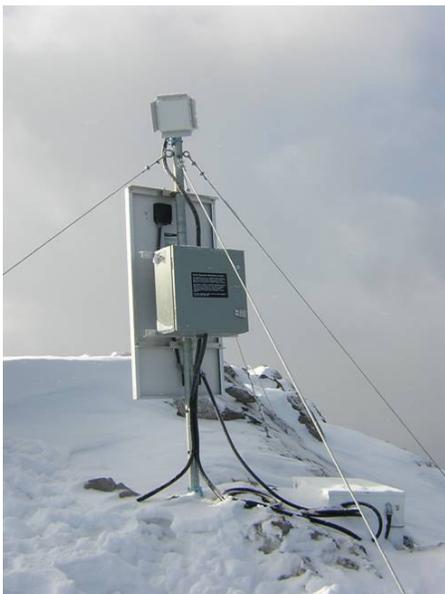
Figure 8. Typical surface seismic station installed on South Peak of Turtle Mountain.

The surface microseismic system was designed and deployed by Gennix Technology Corp. of Calgary, Alberta between October 2003 and March 2004. Six motion sensing stations (Fig. 8) were installed at various locations on Turtle Mountain. Three 28 Hz triaxial geophones connected in series were cemented into outcrops at each of the stations. Station locations were selected on the basis of array design analysis and consideration of sunlight available to provide solar power.

There are a number of components associated with each surface seismic station, including a microprocessor, power control unit, A/D converters, a GPS antenna and receiver, a radio transceiver and a telemetry antenna. Each station is powered by four 12V deep-cycle batteries, charged by a 100W solar panel. One station near the old Frank Mine entrance (River Station) is also powered by a wind turbine as this location is the most shaded of all of the stations.

In addition to the three channels of input from the geophone, the microprocessor receives timing and positional data from a GPS receiver whose antenna is mounted on the solar-panel mast. Seismic and GPS data are wirelessly transmitted to the control centre at FSIC.

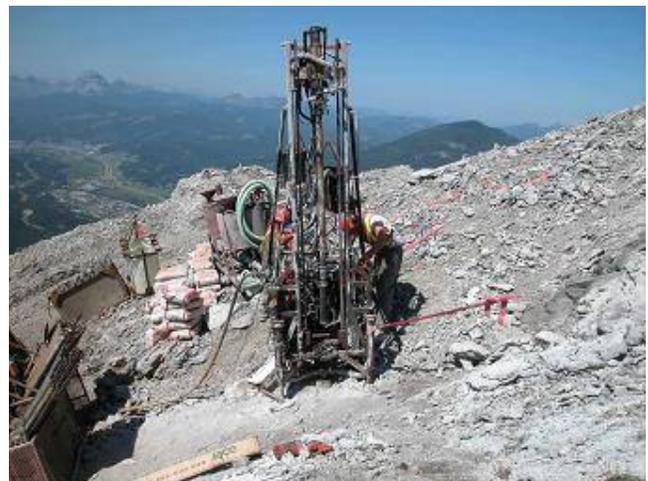
Figure 9. Air rotary drill used on South Peak during installation of subsurface geophones.

In addition to the surface seismic system, two 28 Hz triaxial geophones supplied by Weir Jones Engineering Corp. of Vancouver, BC were installed by AMEC Earth and Environmental in an air rotary drillhole completed to a depth of 62.5 m on South Peak. The borehole was drilled using a helicopter portable drill rig (Fig. 9) operated by Bertram Drilling Limited of Carbon, Alberta.

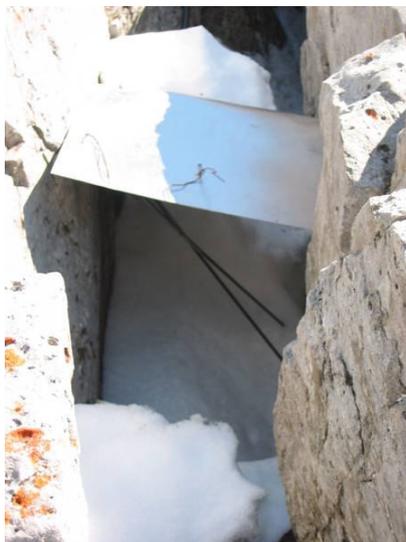
Figure 10. Vibrating wire crackmeters installed across a major fissure. The metal snow roof is to protect the instruments.

A series of 20 vibrating wire crackmeters (Fig. 10) were installed by Danaus Corp. of Edmonton, Alberta between October 2003 and November 2004. These instruments were located in eight clusters across major fissures on the west side of Turtle Mountain downslope of South Peak. Five of these clusters had crackmeters installed in triplets to determine a true movement vector.

Although protective metal snow roofs were installed at each crackmeter cluster to shed snow, several instruments were affected by drifting snow and ice build-up in late 2004. Further protective measures are planned next field season.

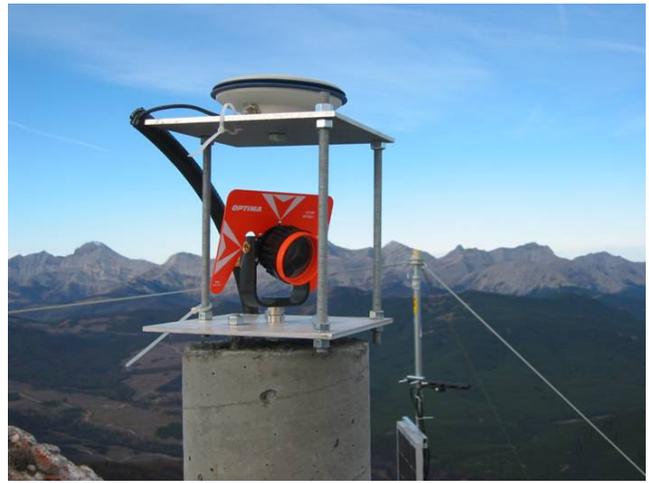
Figure 11. Combination theodolite prism and GPS antenna mounted on a concrete pillar near South Peak.

To supplement the information from crackmeters, a robotic optical survey system was deployed by Danaus Corp. in 2004. A computer-automated Trimble theodolite was mounted in a protected area at FSIC, and ten prisms (Fig. 11) were mounted at strategic points on South Peak and Third Peak. Readings of the position of each prism are taken hourly, and relative changes in position between each prism on South Peak and that on Third Peak

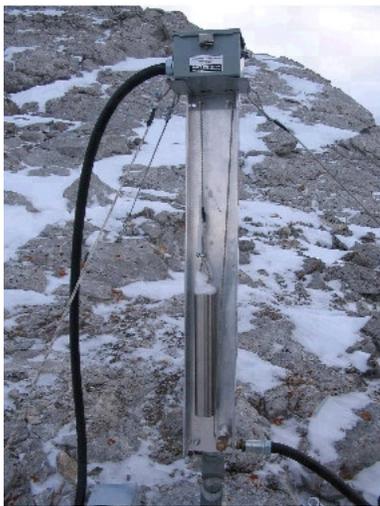
Figure 12. Typical surface extensometer head assembly with housing removed to show suspended weight.

Extensometer locations were selected such that the head assembly (upslope end) and anchor (downslope end) were installed in exposed bedrock, with the extensometer cable roughly parallel to the possible direction of movement. The signal cable from the head assembly of each extensometer was run through protective conduit to the Campbell Scientific CR-10X data logger at the enclosure near the South Peak borehole. Displacement data from these instruments is transmitted to the control centre at FSIC via the Provincial Building in Blairmore.

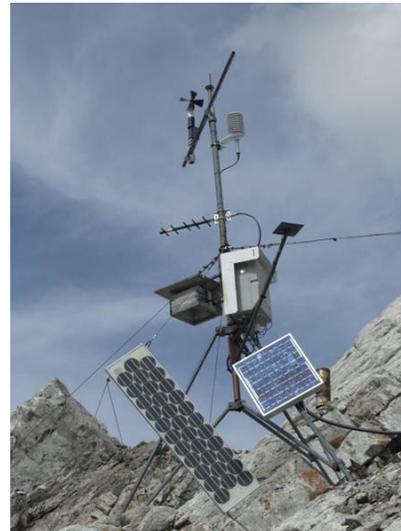
Figure 13. Refurbished weather station on the west side of South Peak.

The original weather station installed on South Peak in the 1980s was refurbished by Danaus Corp. in December 2003. The weather station (Fig. 13) monitors barometric pressure, air temperature, relative humidity, wind speed, wind direction, solar radiation, precipitation, and rock temperature near the station. Additional temperature data are measured by each of the vibrating wire crackmeters. These data are collected on a Campbell Scientific CR-10X data logger near the weather station and transmitted to the FSIC control centre by radio telemetry via Blairmore.

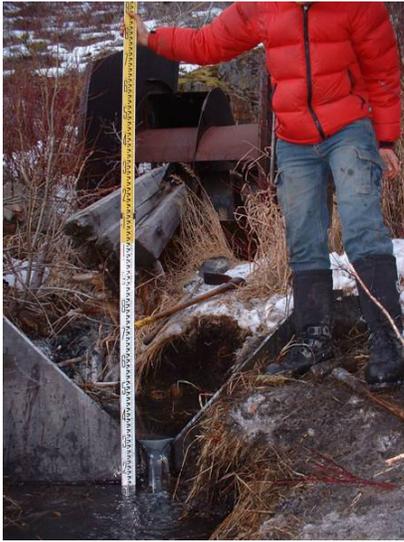
Figure 14. Outflow weir installed at the Frank Mine entrance.

Matrix Solutions of Calgary, Alberta fabricated and installed a metal weir across the outflow path from the mine entrance (Fig. 14). A Keller pressure transducer installed inside a piece of screened PVC pipe bored into the streambed provides a continuous measure of water level. Data from the outflow monitoring system are collected on a Campbell Scientific CR510-55 datalogger connected to the telemetry system at the nearby surface seismic station (River Station). Data are transferred by radio telemetry to FSIC and stored in the SQL database.
