Arsenic Pollution in Lake Olomega, El Salvador

Armeda Van Dam
Peace Corps Master's
International Program

El Salvador

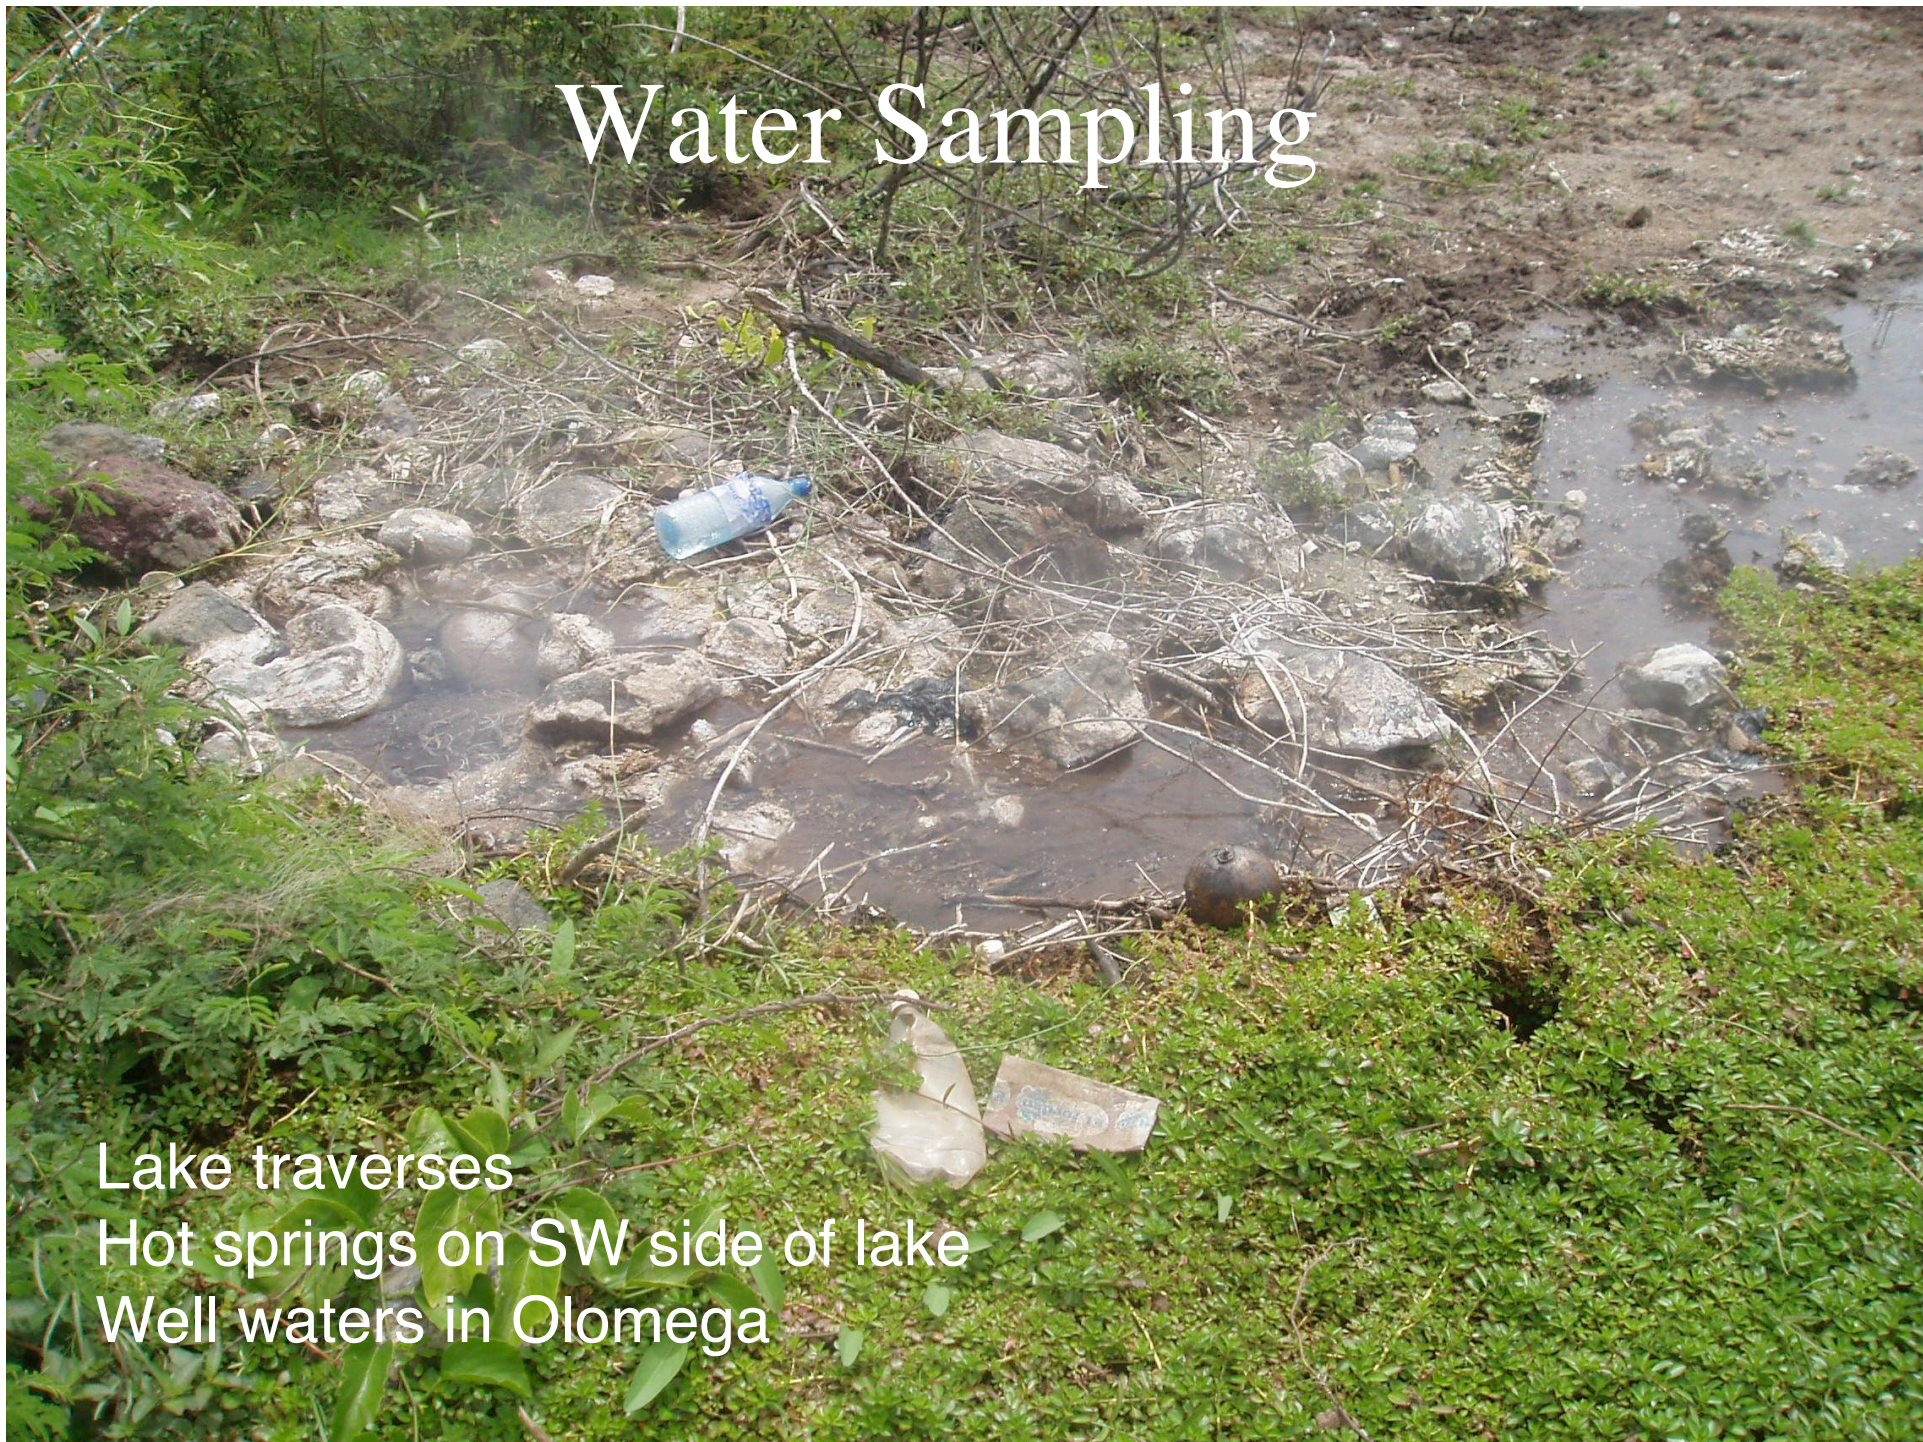
Water Sampling

Lake traverses
Hot springs on SW side of lake
Well waters in Olomega

open lake

TESTING INFORMATION			REGULATORY INFORMATION			
Analyte Name	Result (mg/L)	Date Tested	RL (mg/L)	MCL/AL (mg/L)	Method	CAS #
Chloride	9	11/14/2006	4		SM 4500-Cl E	7647-14-5
Fluoride	0.1	11/14/2006	0.1	4.0	SM 4500 FC	16984-48-8
Hardness as CaCO ₃	41	11/14/2006	10		SM 2340 C	HARD-00-C
Iron	0.1	11/14/2006	0.1		SM 3500 FeB	7439-89-6
Nitrate as N	Not Detected	11/14/2006	0.4	10	SM 4500 NO ₃ F	14797-55-8
Nitrite as N	Not detected	11/14/2006	0.05	1	SM 4500 NO ₃ F	14797-65-0
Sodium	19	11/14/2006	5		SM 3500 NaB	7440-23-5
Sulfate	6	11/14/2006	5		SM 4500 SO ₄ E	14808-79-8

hot spring

TESTING INFORMATION			REGULATORY INFORMATION			
Analyte Name	Result (mg/L)	Date Tested	RL (mg/L)	MCL/AL (mg/L)	Method	CAS #
Chloride	99	11/14/2006	4		SM 4500-Cl E	7647-14-5
Fluoride	2.4	11/14/2006	0.1	4.0	SM 4500 FC	16984-48-8
Hardness as CaCO ₃	72	11/14/2006	10		SM 2340 C	HARD-00-C
Iron	Not detected	11/14/2006	0.1		SM 3500 FeB	7439-89-6
Nitrate as N	1.8	11/14/2006	0.4	10	SM 4500 NO ₃ F	14797-55-8
Nitrite as N	Not detected	11/14/2006	0.05	1	SM 4500 NO ₃ F	14797-65-0
Sodium	200	11/14/2006	5		SM 3500 NaB	7440-23-5
Sulfate	189	11/14/2006	5		SM 4500 SO ₄ E	14808-79-8

Results - November, 2006

- **Arsenic in hot spring (0.1 mg/l)**
- **Arsenic in one lake shore sample (0.1 mg/l)**
- **No arsenic in open lake (N=8)**
- **No arsenic in Olomega human hair (N=9)**
- **No arsenic in Olomega wells (N=4)**
